SUNFLOWER TURBOALTERNATOR CSU I-3A

4329-HOUR-TEST SUMMARY REPORT

Prepared under Contract No. NAS 5-462 by
THOMPSON RAMO WOOLDRIDGE, INC.
Cleveland, Ohio
for .

NATIONAL AERONAUTICS AND SPACE ADMINISTRATION • WASHINGTON, D. C. • APRIL 1965

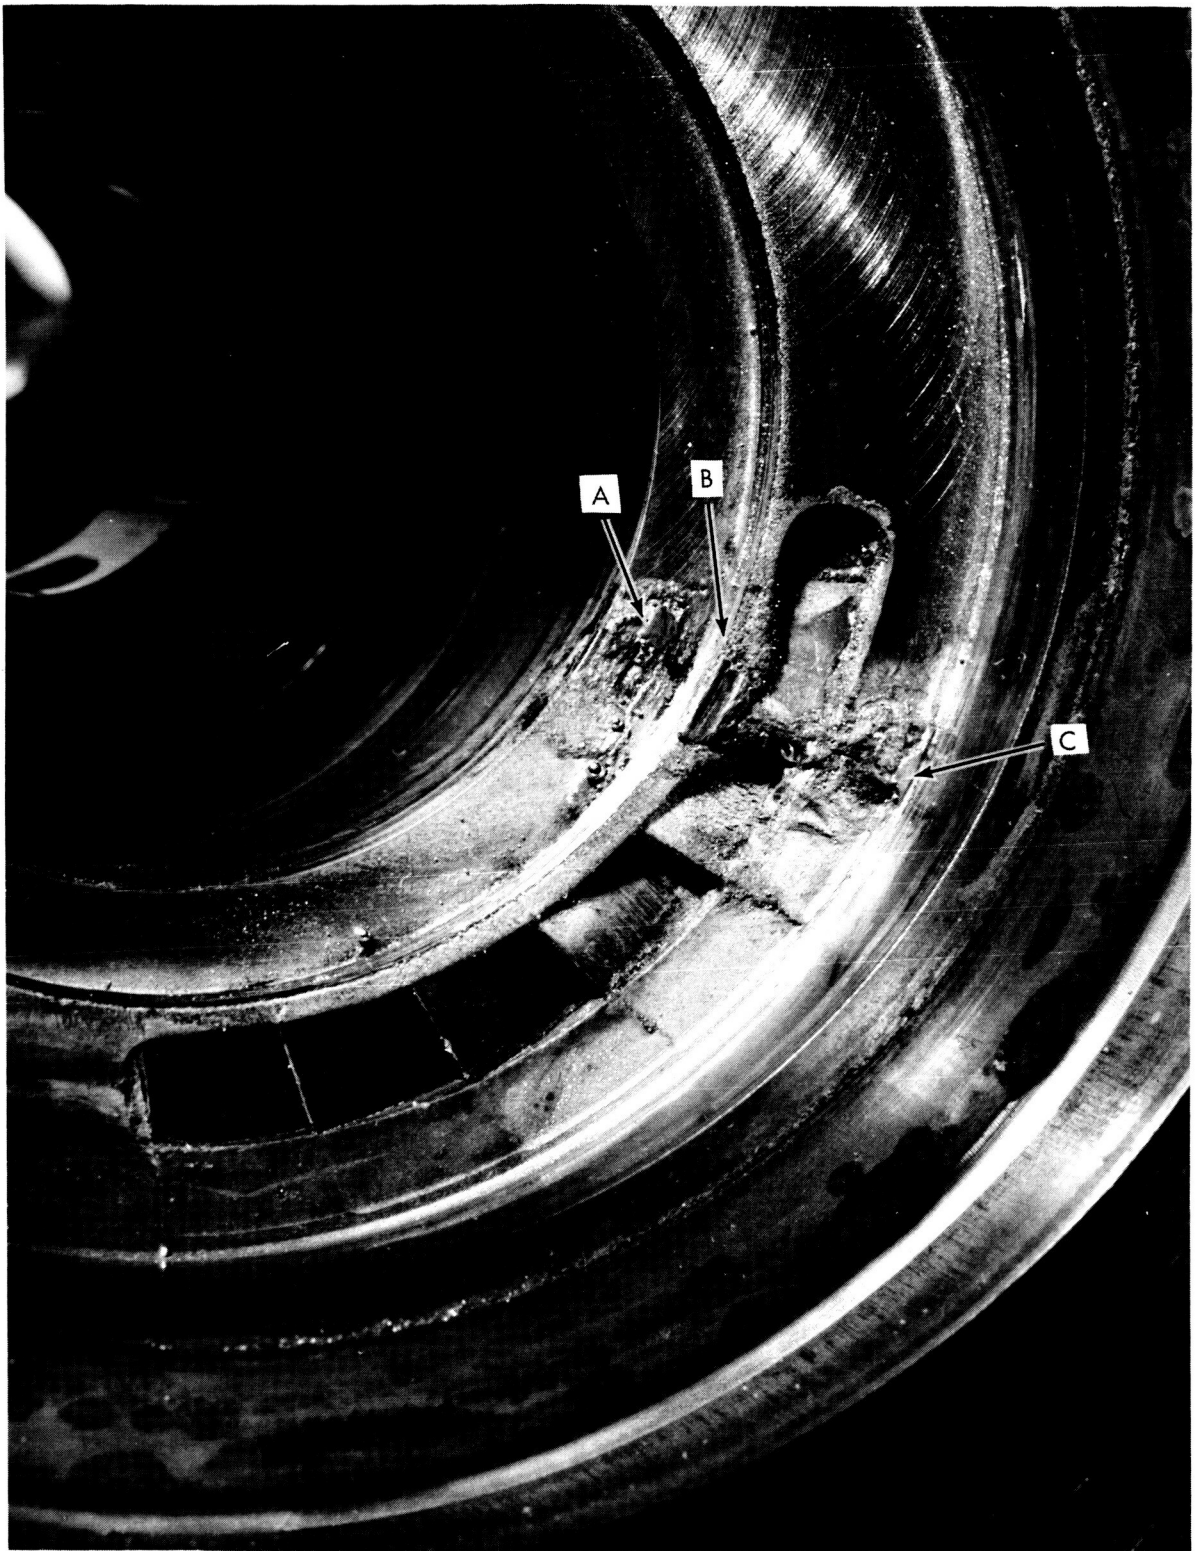
FIGURE 2

TURBINE INLET HOUSING NOZZLE DEPOSITS

There was some depositing on portions of the turbine as well as the first stage nozzle. The third stage nozzle was not affected but the first and second stage nozzle throat areas were both reduced over 20% by deposits. Metallurgical analysis of the deposits in the turbine (including those that caused the failure) revealed that the major constituent was cobalt which could only have come from the Haynes #21 housing. The balance of the system is predominately austenitic stainless steel and corrosion was clearly evidenced in the turbine inlet housing.

The main reason for the corrosion in the turbine inlet housing was the loss of superheat which lead to mercury condensation in that area. The loss of superheat was attributed to the wrap around turbine inlet scroll which was added to more evenly distribute the heat in the turbine bearing area. It has now been demonstrated that it is no longer required and is, in fact, detrimental to the operation of the unit.

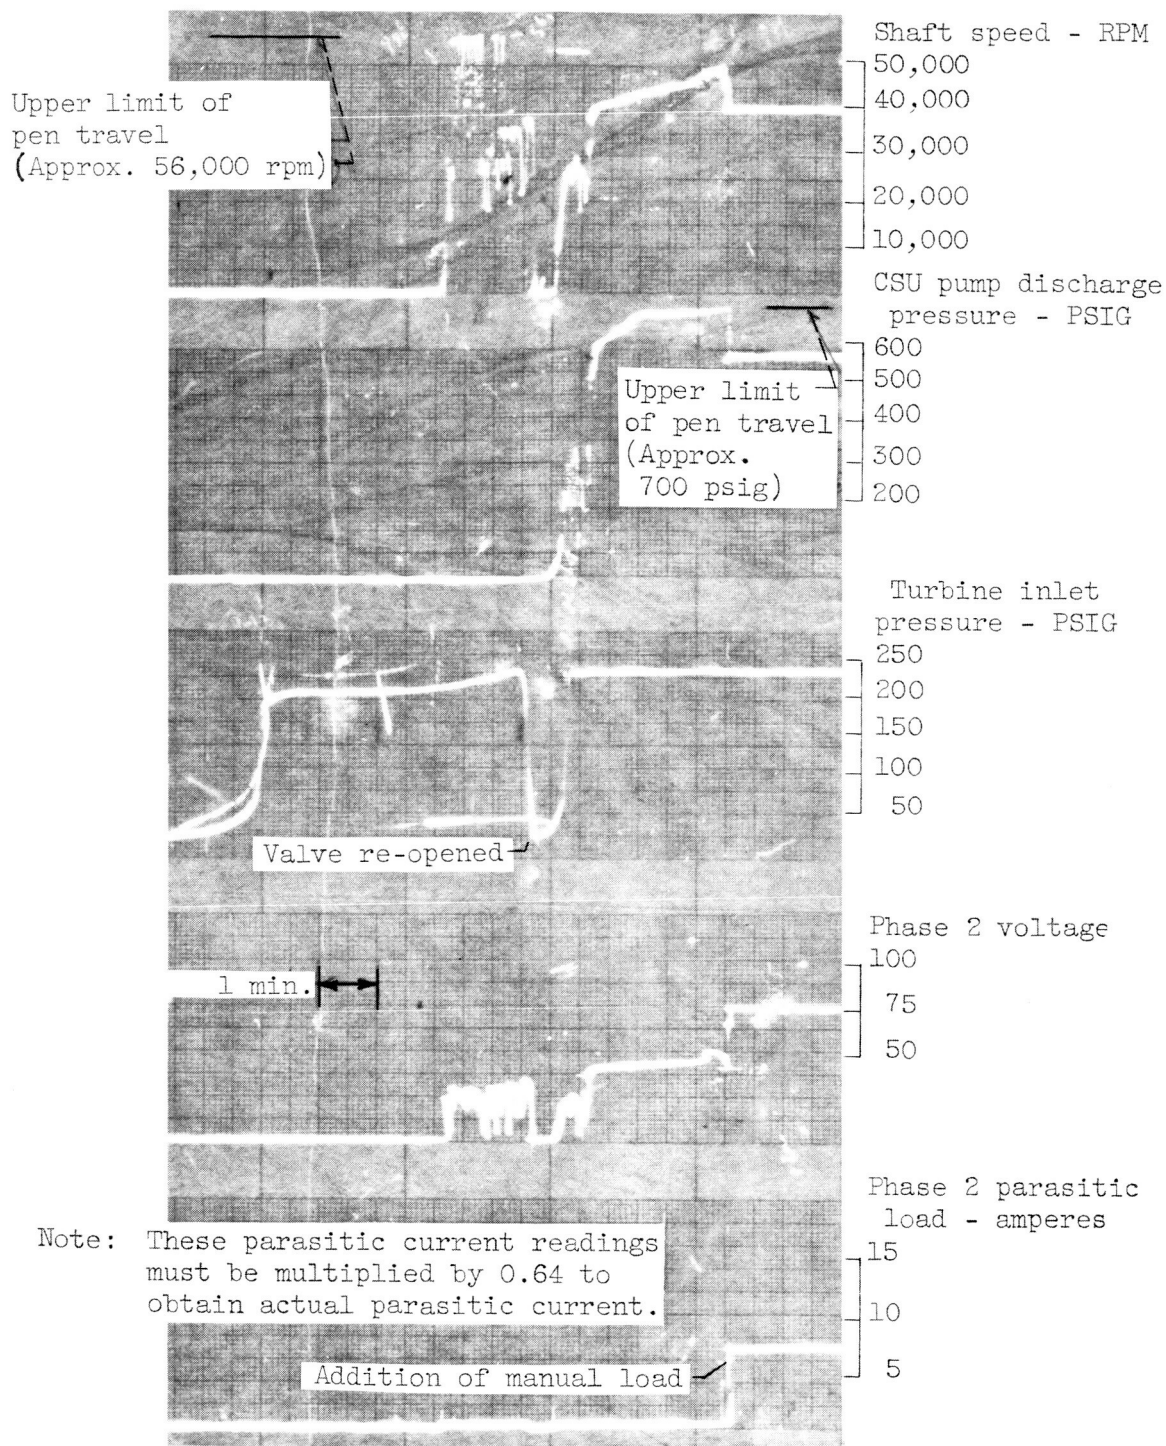
FIGURE 16

RECORDING OSCILLOGRAPH RECORD OF FINAL MINUTES OF SUNFLOWER
CSU I-3A-3 TURBOALTERNATOR TEST

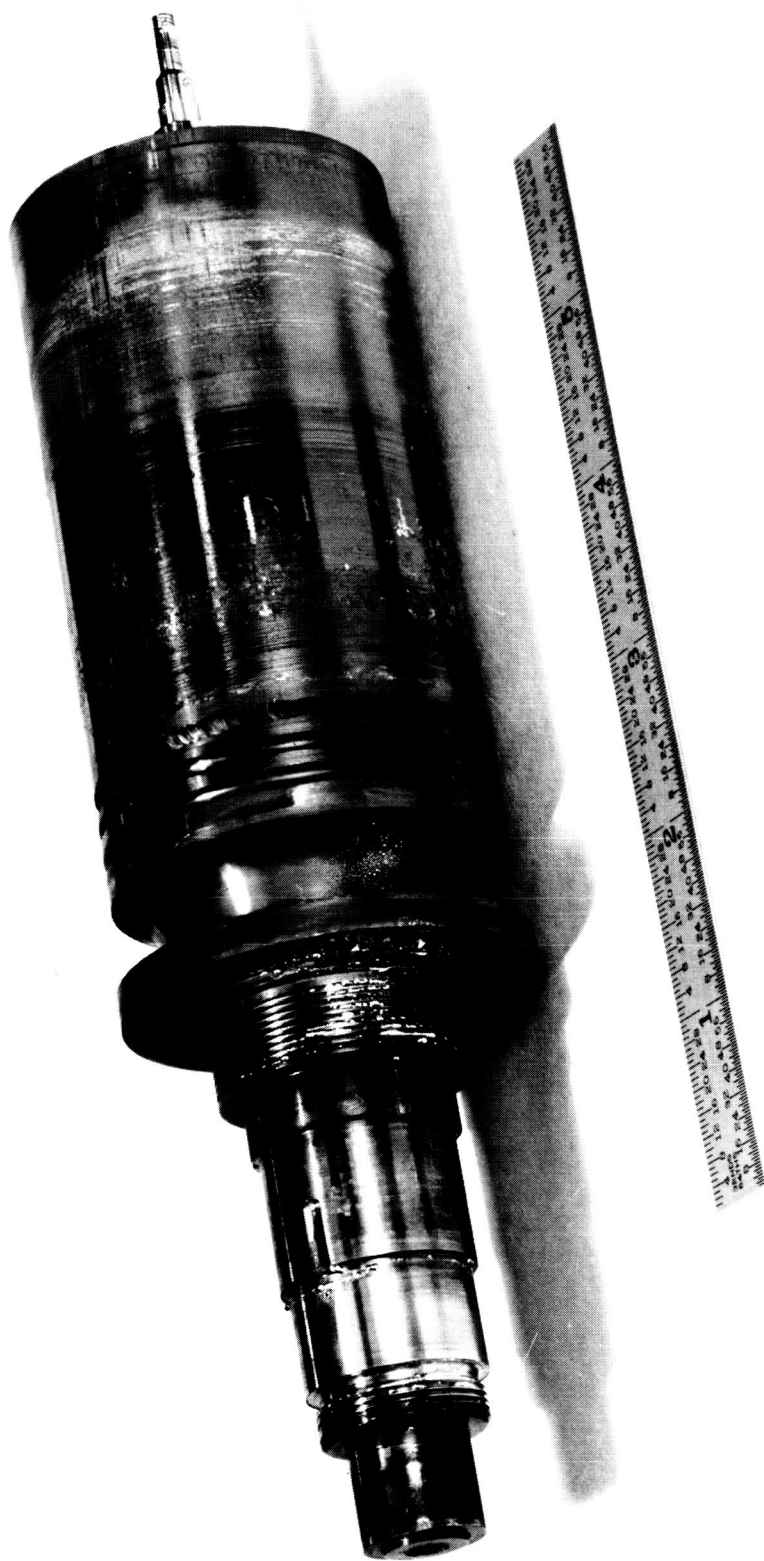
FIGURE 20

It would be difficult to assess the condition of the alternator bearing just prior to the CSU failure because of the galling and welding resulting from the seizure. However the thrust face of the journal sleeve is in excellent condition. Metallurgical examination of the crack in the sleeve indicates that the crack does not appear to be associated with the seizure of the bearing. The bushing had over nine months of operating time. See Fig. 21 for a photograph of the sleeve after removal from the bushing.

SUNFLOWER CSU I-3A SHAFT, PARTIAL DISASSEMBLY, PRIOR TO CLEANING AFTER 4328 HOURS OPERATION

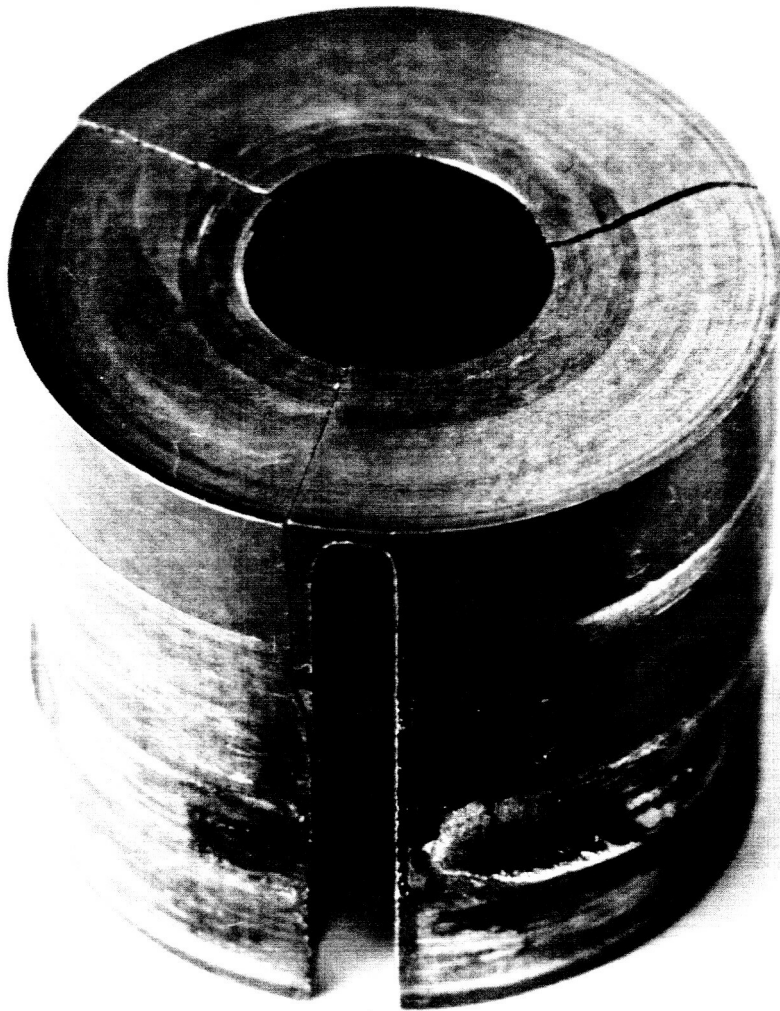
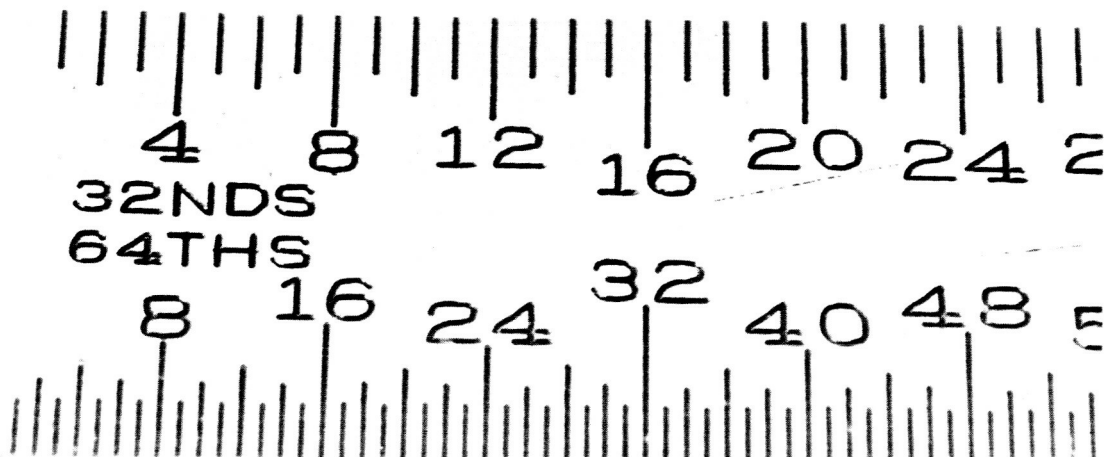
FIGURE 21

SUNFLOWER CSU I-3A ALTERNATOR BEARING SLEEVE AFTER 4328 HOURS OPERATION

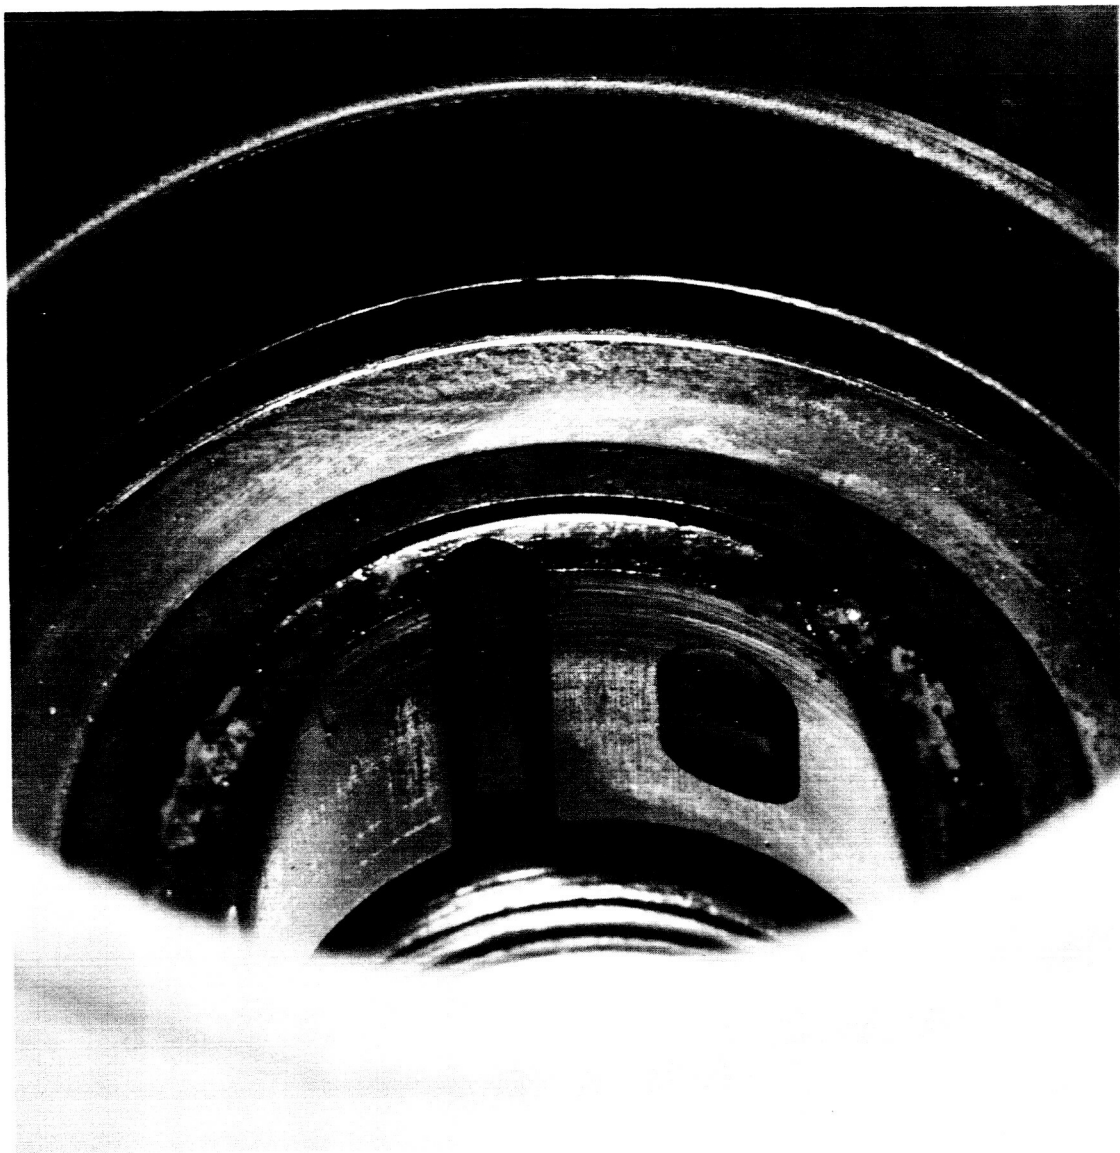
FIGURE 22

The bearings were free of any visible damage or wear except for a very light rub, or wipe mark, on the outboard end of the turbine bearing. Also the finish on all bearing surfaces was very good relative to the assembly finishes. The excellent condition of the thrust bearing implies that the stalling forces were largely in a radial plane. The relative lack of damage on the journal bearings indicates that the shaft was stalled in a highly concentric manner with respect to the bearing; the turbine journal for example had less than 0.001 inches diametral clearance. The condition of the

SUNFLOWER CSU I-3A TURBINE BEARING BUSHING AFTER 4328 HOURS OPERATION

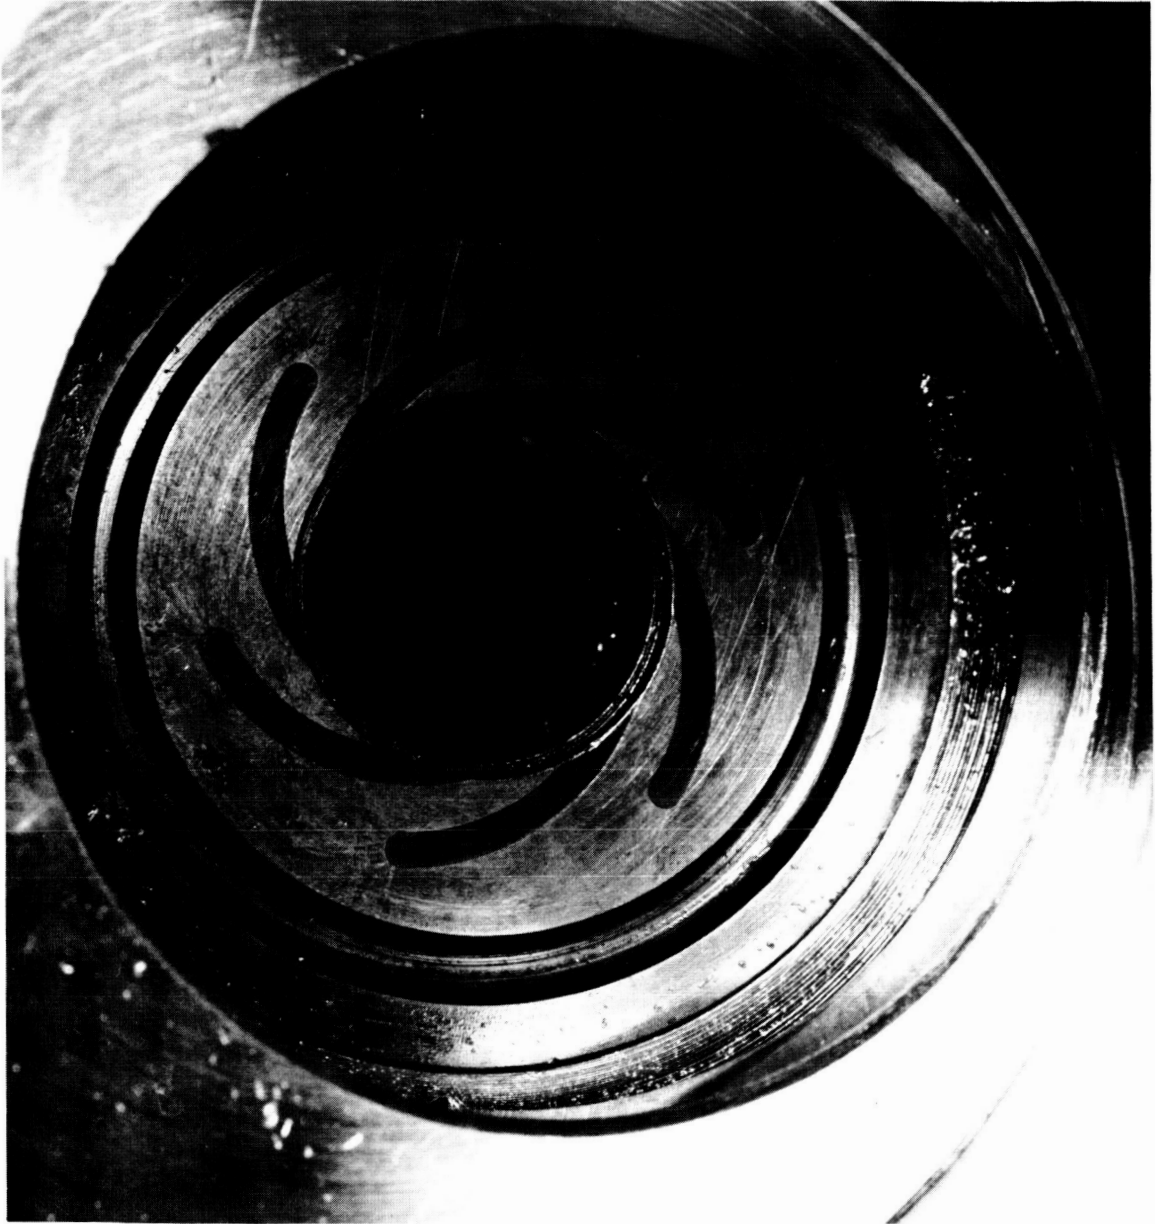
FIGURE 23

SUNFLOWER CSU I-3A THRUST BEARING AFTER 6676 HOURS OPERATION

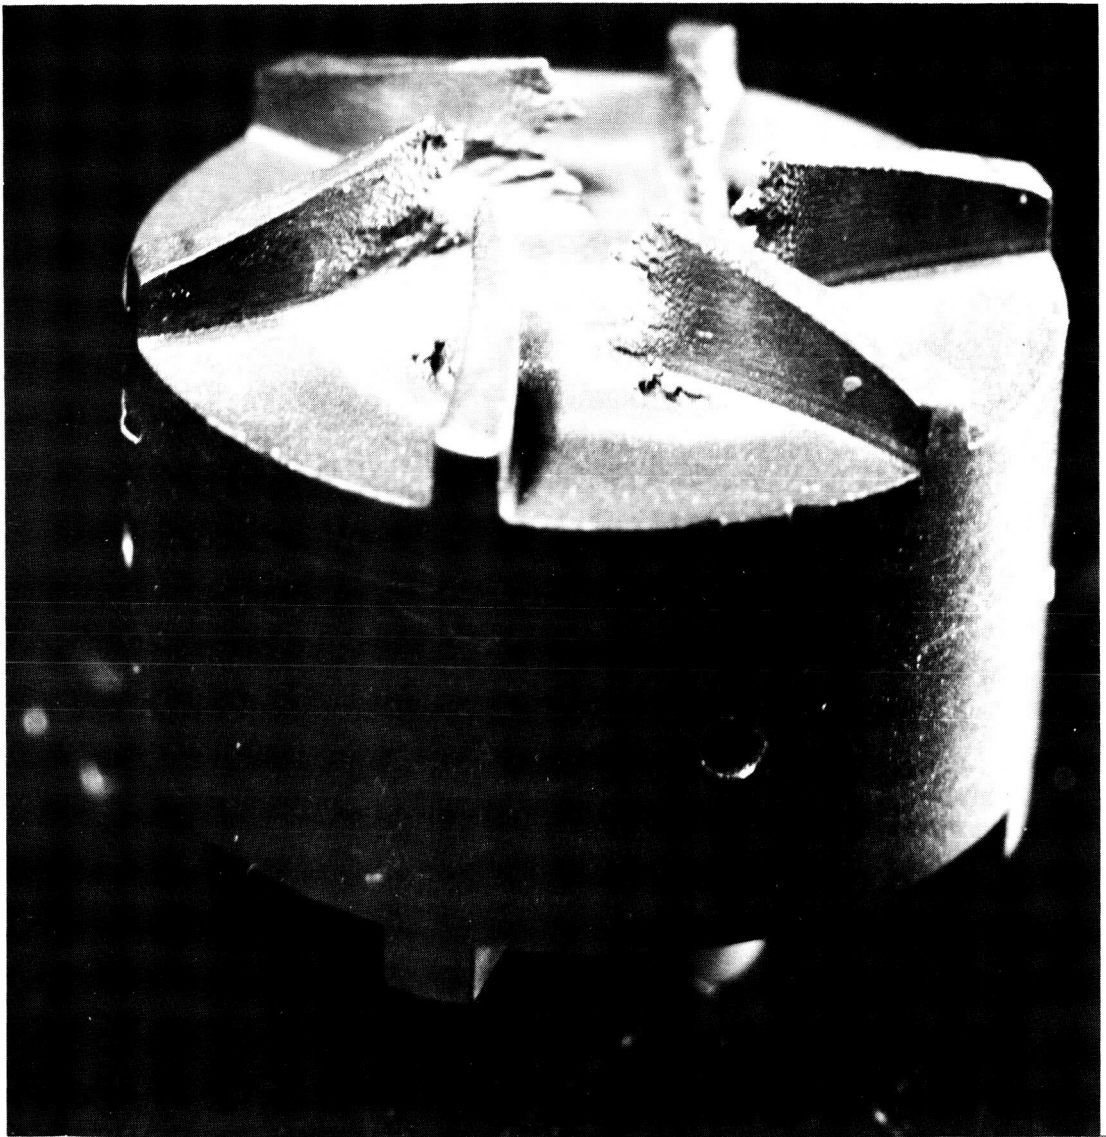
FIGURE 24

The pump impeller displayed cavitation erosion at the blade entrance tips, at the blade roots on the convex side, and in the face of the impeller body. The blade tip and root erosion are in areas of normally low pressure and attest to insufficient NPSH at the impeller inlet. On the other hand, the face pits may have been caused by a mismatch between actual blade curvature versus theoretical optimum curvature or by insufficient impeller NPSH. Insufficient NPSH was attributed to partial blockage of the jet boost pump.

SUNFLOWER CSU I-3A MERCURY PUMP IMPELLER AFTER 4328 HOURS OPERATION

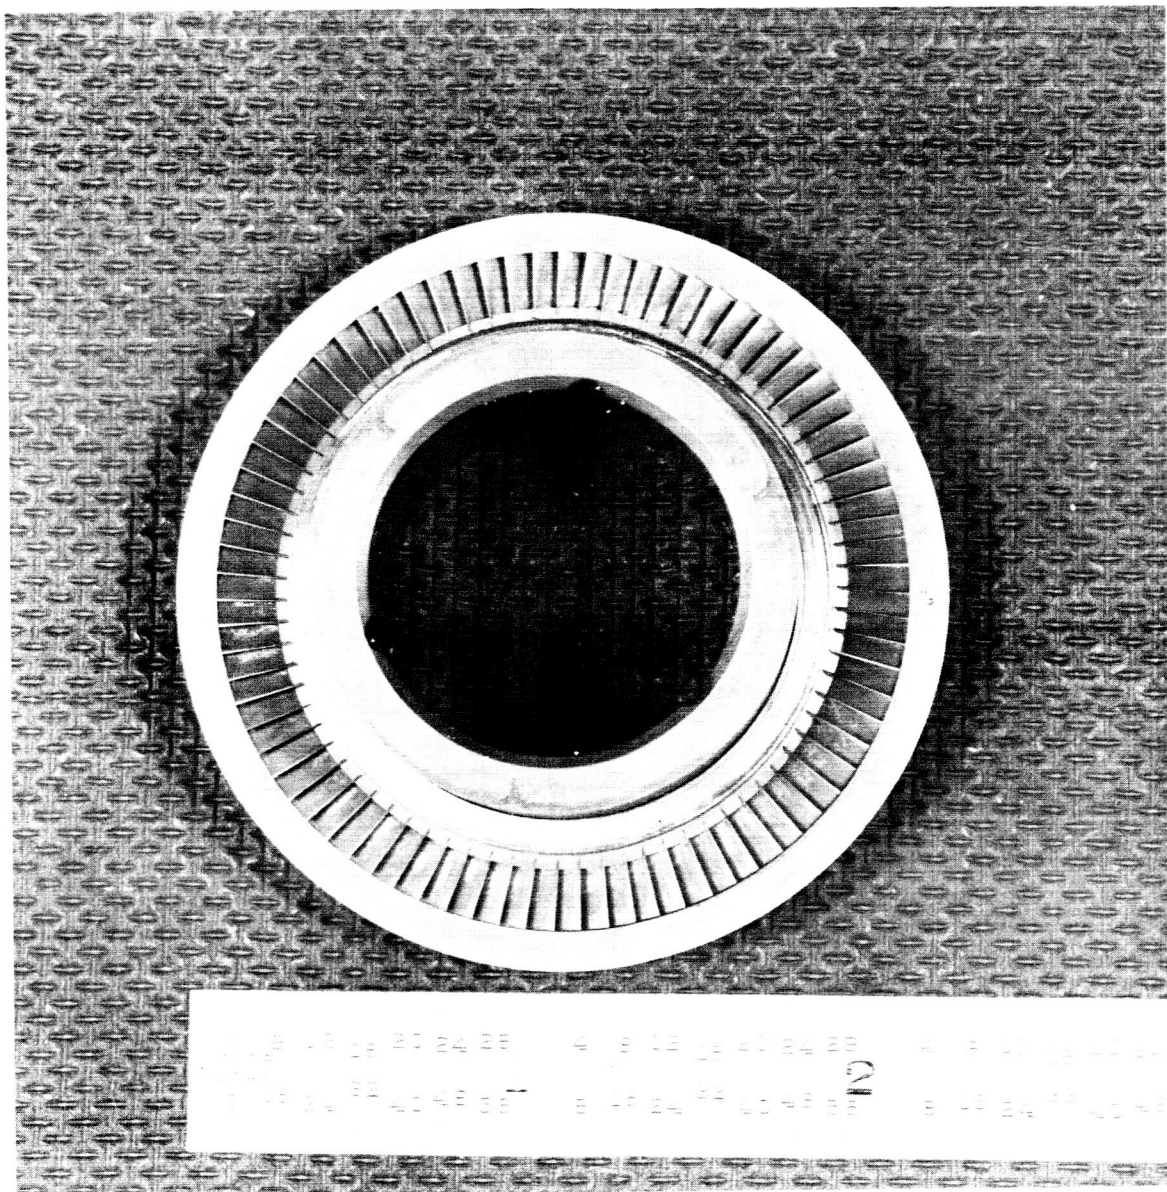
FIGURE 25

The first stage turbine wheel (Fig. 25) sustained a significant amount of damage. During the final, or possibly the final few revolutions of the unit, contact was made between the turbine wheel intermediate ring and the second stage nozzle resulting in discoloration and metal galling. This also caused the intermediate ring, along with the blades and O.D. shroud ring, to be displaced approximately $1/32$ of an inch toward the second stage wheel. The shroud ring of this wheel was loose with inspection indicating a diametral growth of .004 inches from the cold pre-test measurement. The first stage turbine blading appears to be in good condition with negligible erosion damage present.

SUNFLOWER CSU I-3A FIRST STAGE TURBINE WHEEL DISCHARGE SIDE AFTER 4328 HOURS OPERATION

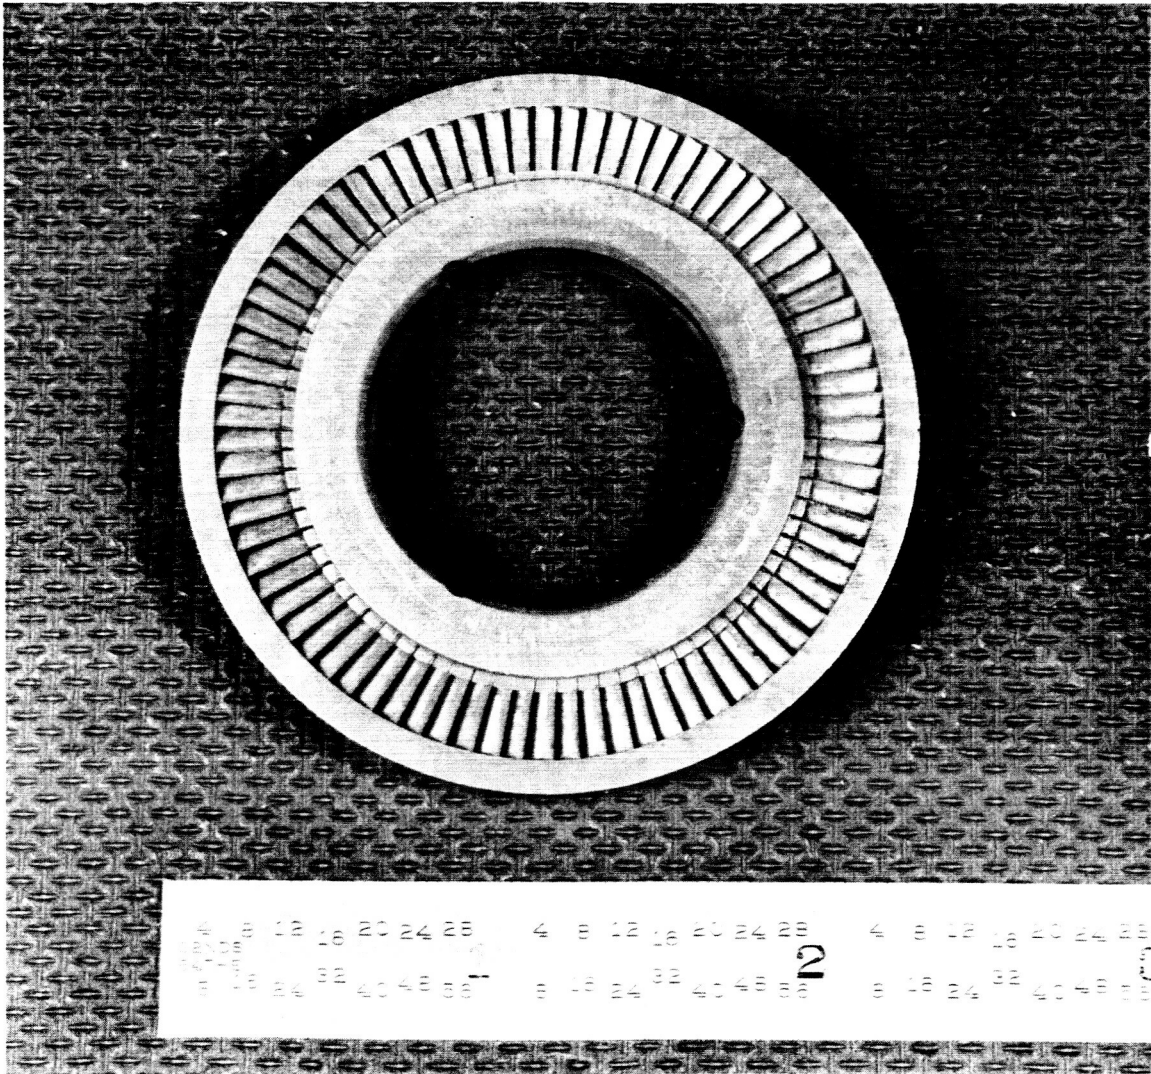
FIGURE 26

SUNFLOWER CSU I-3A FIRST STAGE TURBINE NOZZLE DISCHARGE SIDE AFTER 4328 HOURS OPERATION

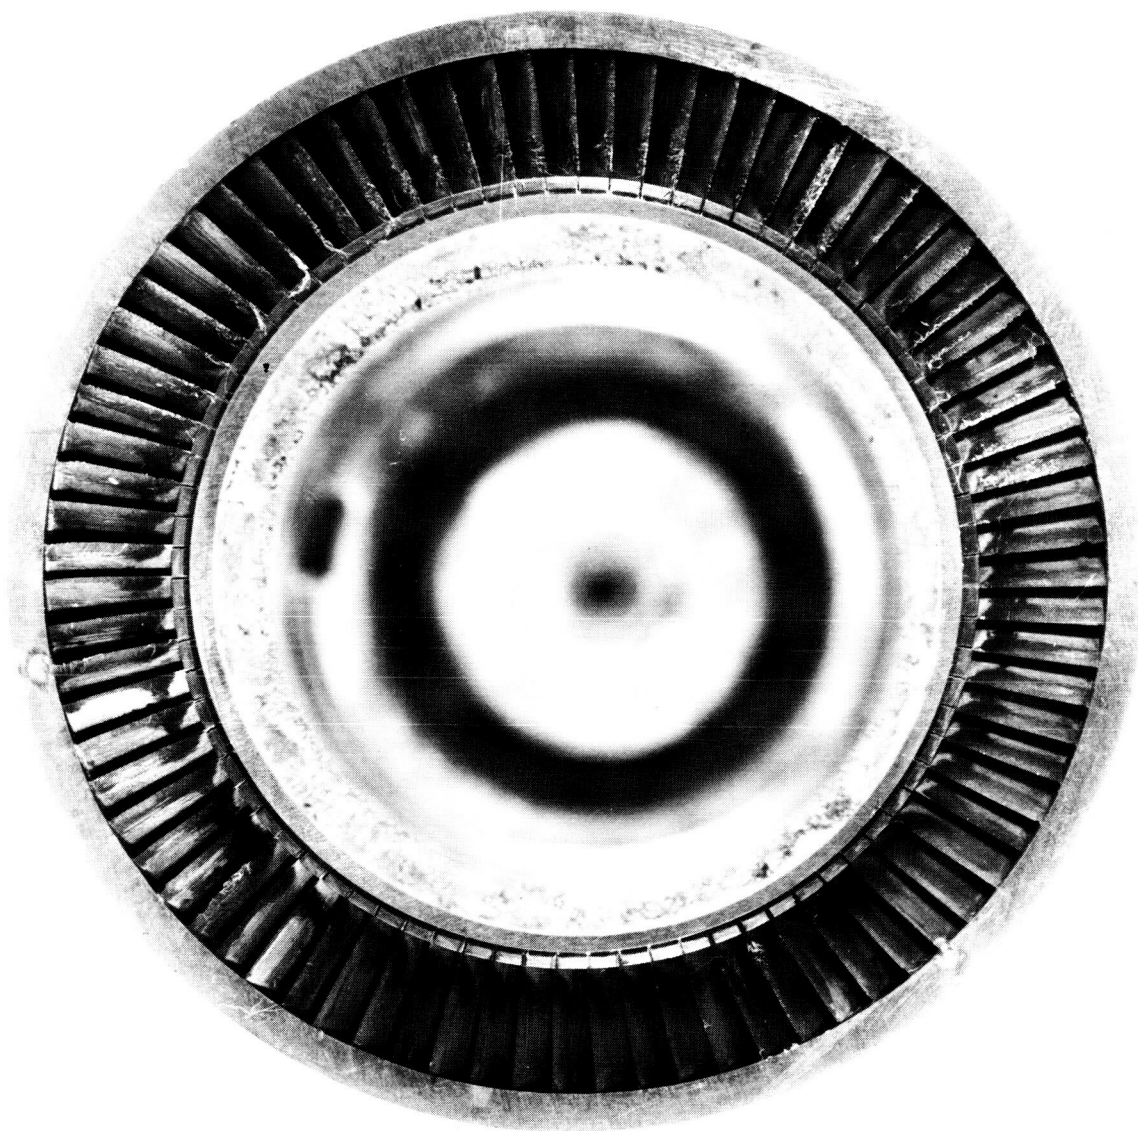
FIGURE 27

SUNFLOWER CSU I-3A THIRD STAGE TURBINE WHEEL INLET SIDE AFTER 4328 HOURS OPERATION

The turbine blades of the third stage wheel had evidence of erosion on the convex side of the leading edge, with little or no erosion on the blade surface areas. Erosion depth was estimated to be 1.6 mils. Some corrosion up to .4 mils was noted on localized working surfaces of the blades. An operating temperature of 700°F was confirmed from the hardness changes incurred during operation. The Larson-Miller master aging curve shown in Figure 34 illustrates how temperature predictions can be made.

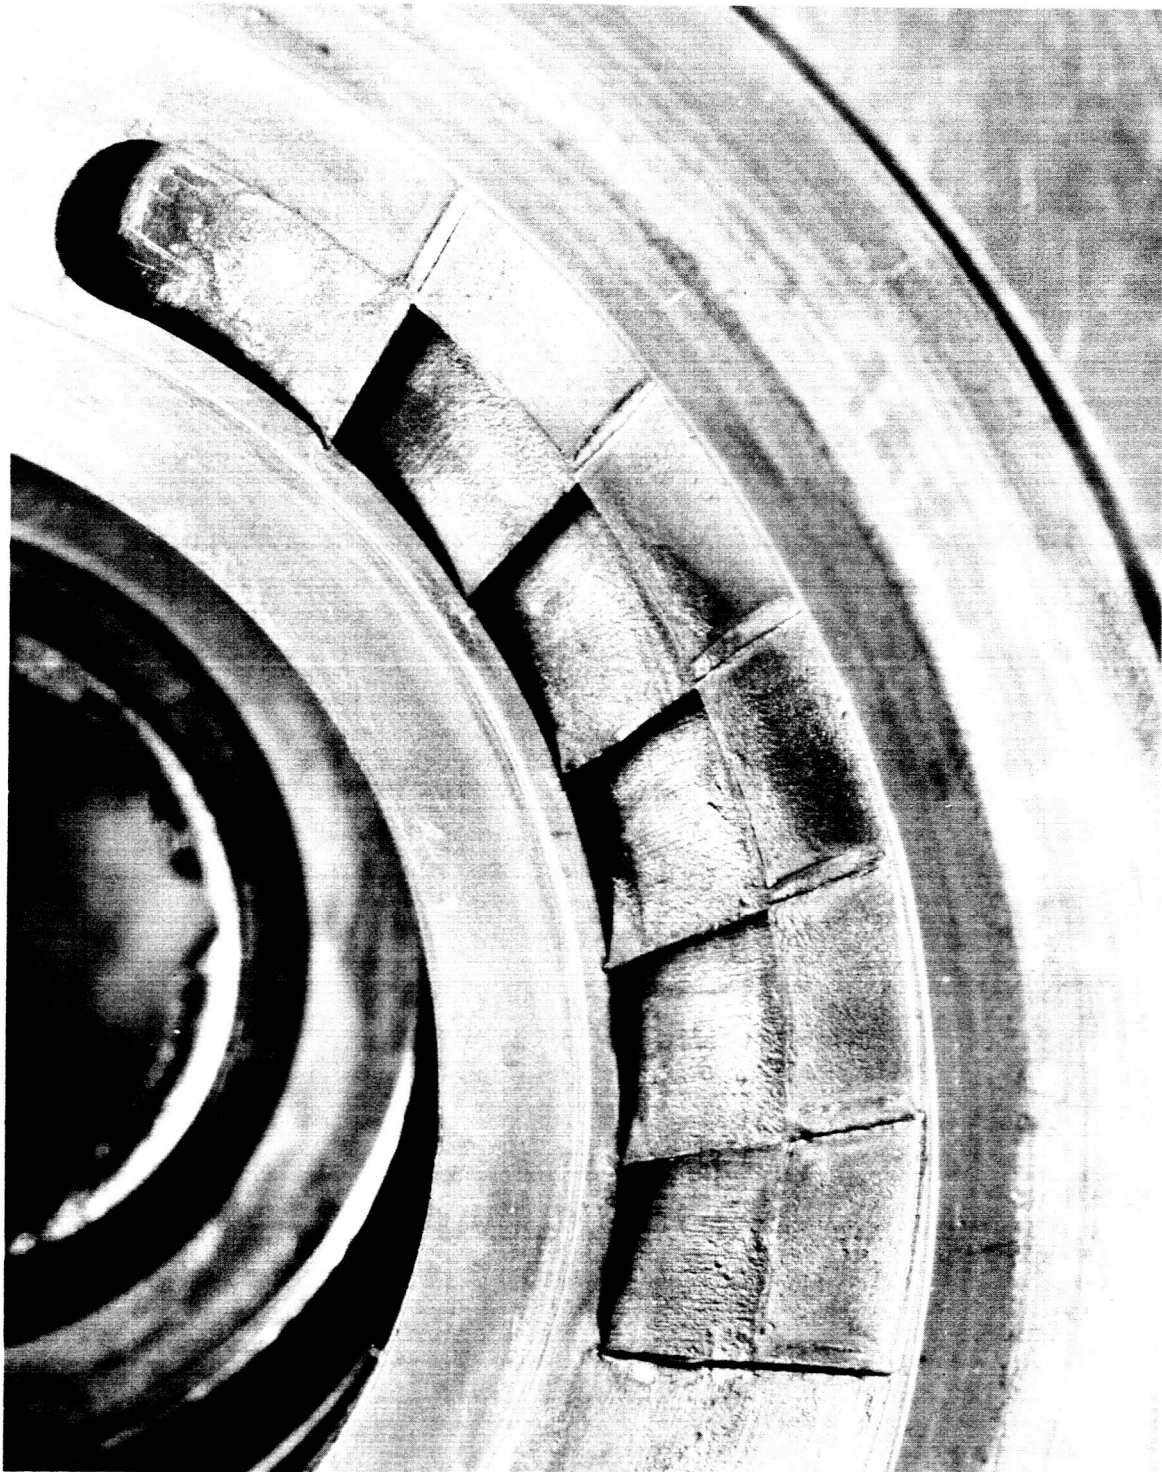
FIGURE 28

SUNFLOWER CSU I-3A FIRST STAGE TURBINE NOZZLE DISCHARGE SIDE AFTER 4328 HOURS OPERATION

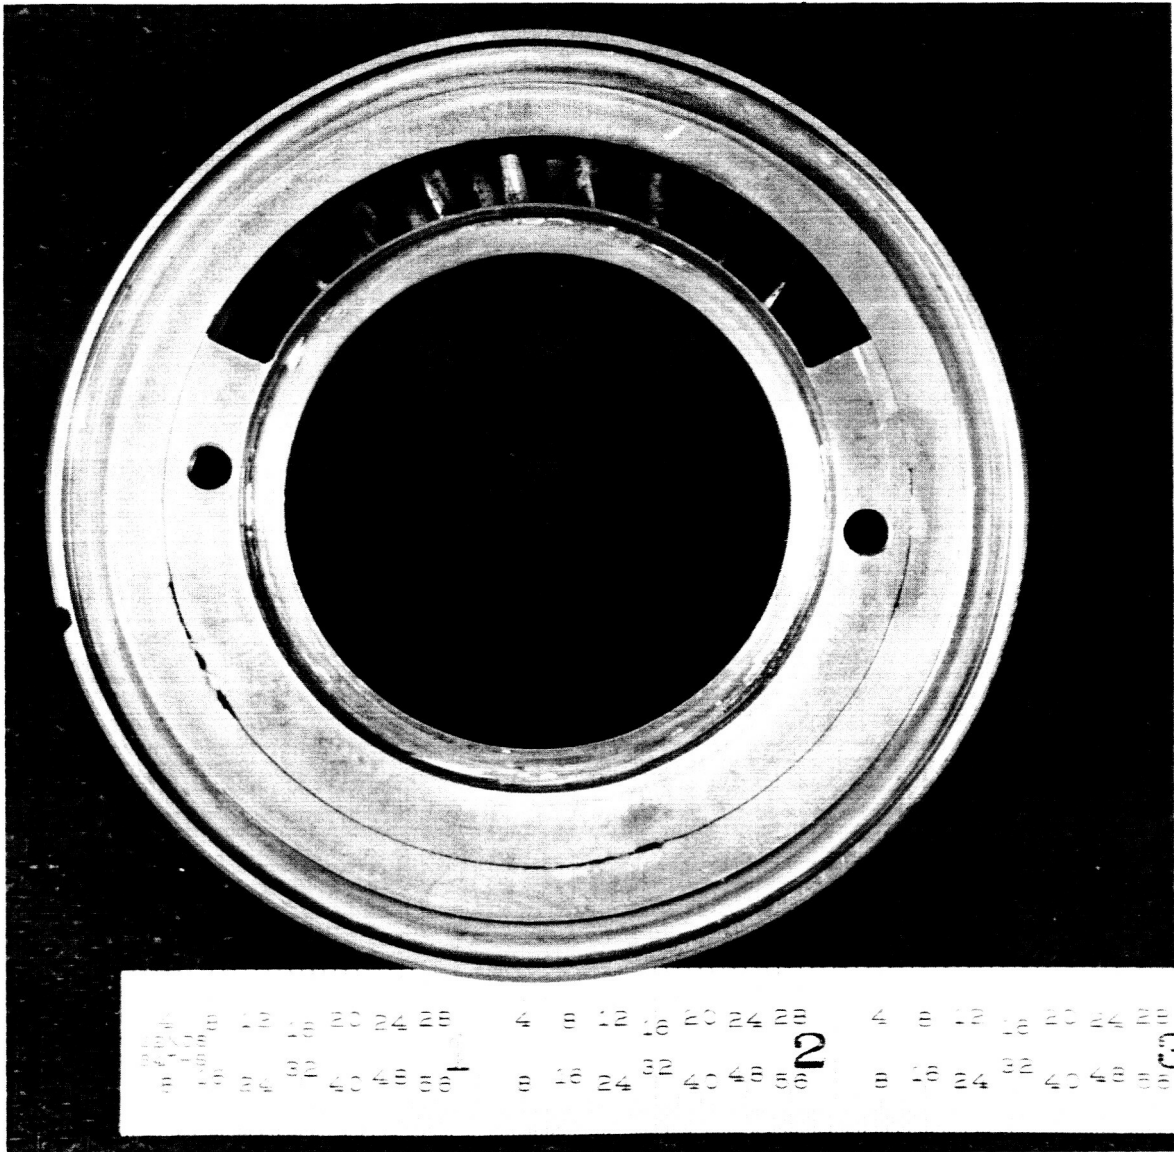
FIGURE 29

SUNFLOWER CSU I-3A SECOND STAGE TURBINE NOZZLE INLET SIDE AFTER 4326 HOURS OPERATION

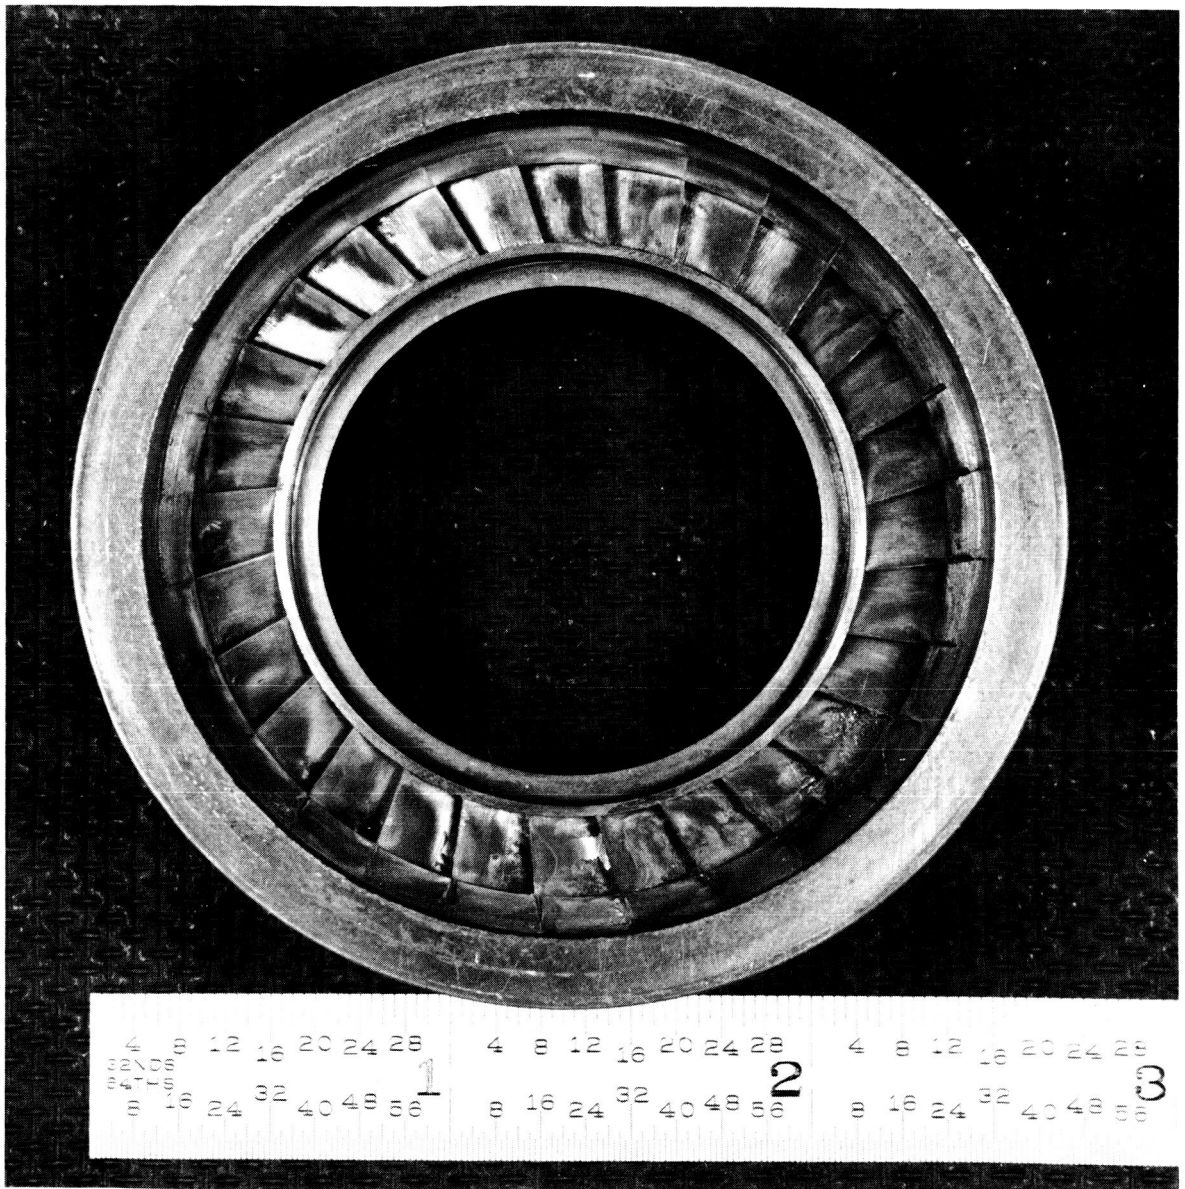
FIGURE 30

SUNFLOWER CSU I-3A THIRD STAGE TURBINE NOZZLE DISCHARGE SIDE AFTER 4328 HOURS OPERATION

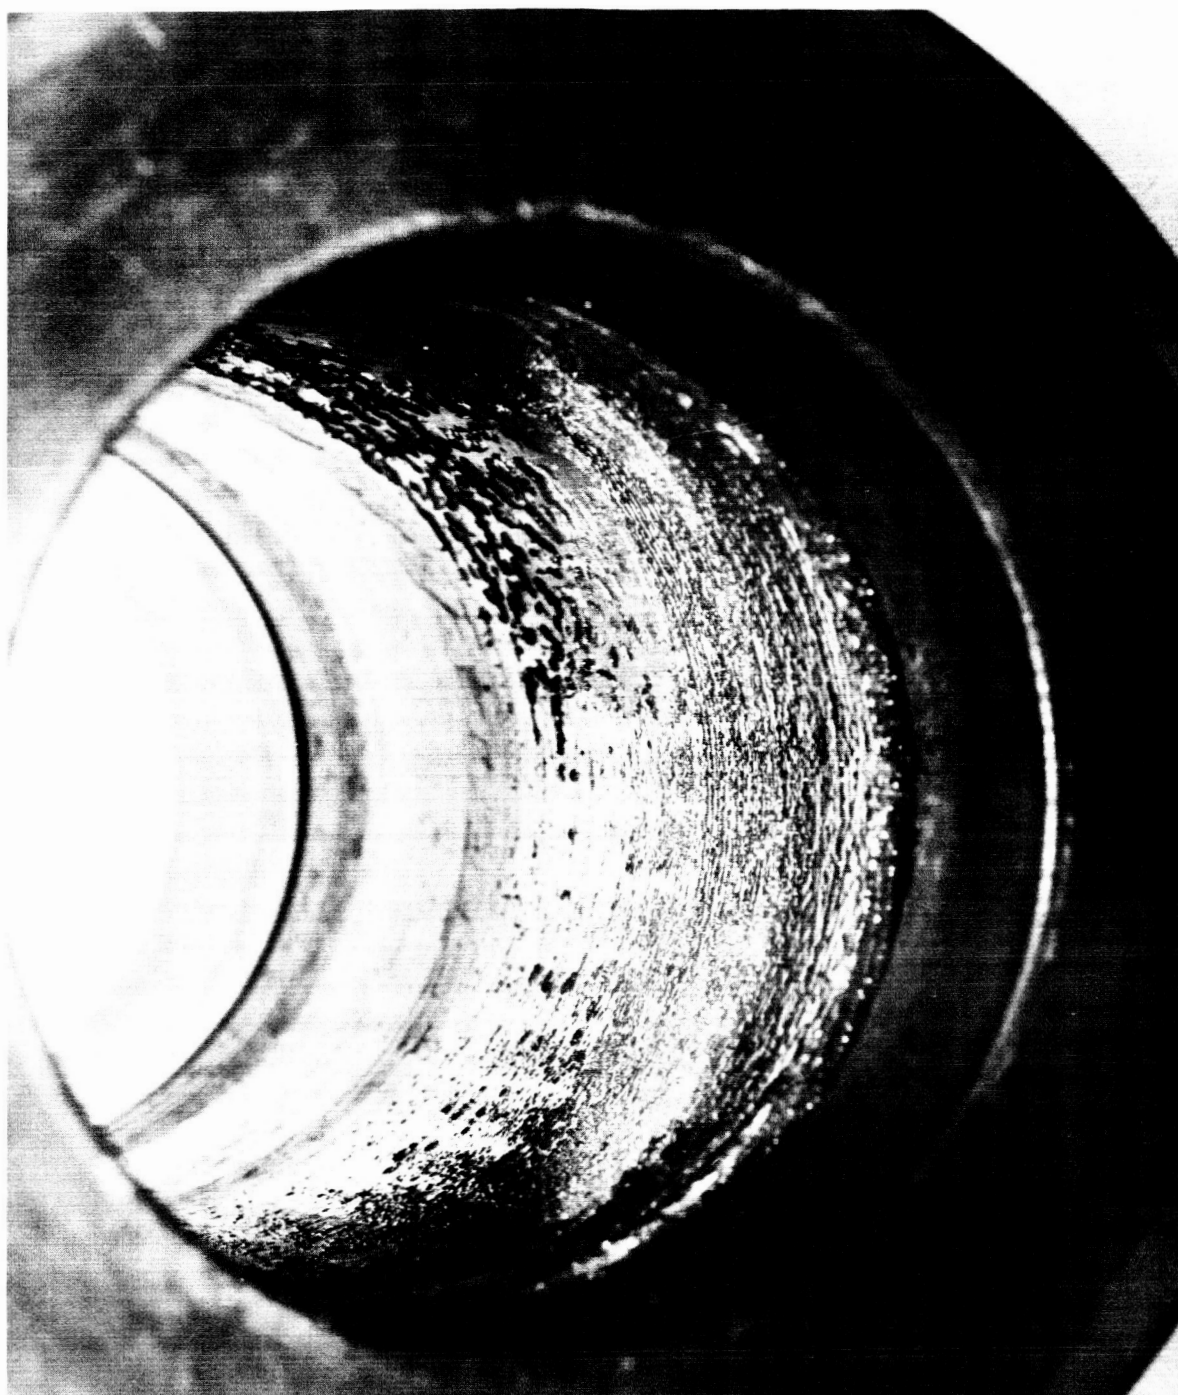
FIGURE 31

The alternator stator was removed with ease from the alternator housing and sustained no damage aside from the melted glass bore seal. It was this melted glass which caused interference between the rotor and stator and ultimate shaft seizure. The turbine and portion of the stator appears to be "bubbly" in nature and pock marked. Figure 31

SUNFLOWER CSU I-3A ALTERNATOR STATOR BORE AFTER 6676 HOURS OPERATION

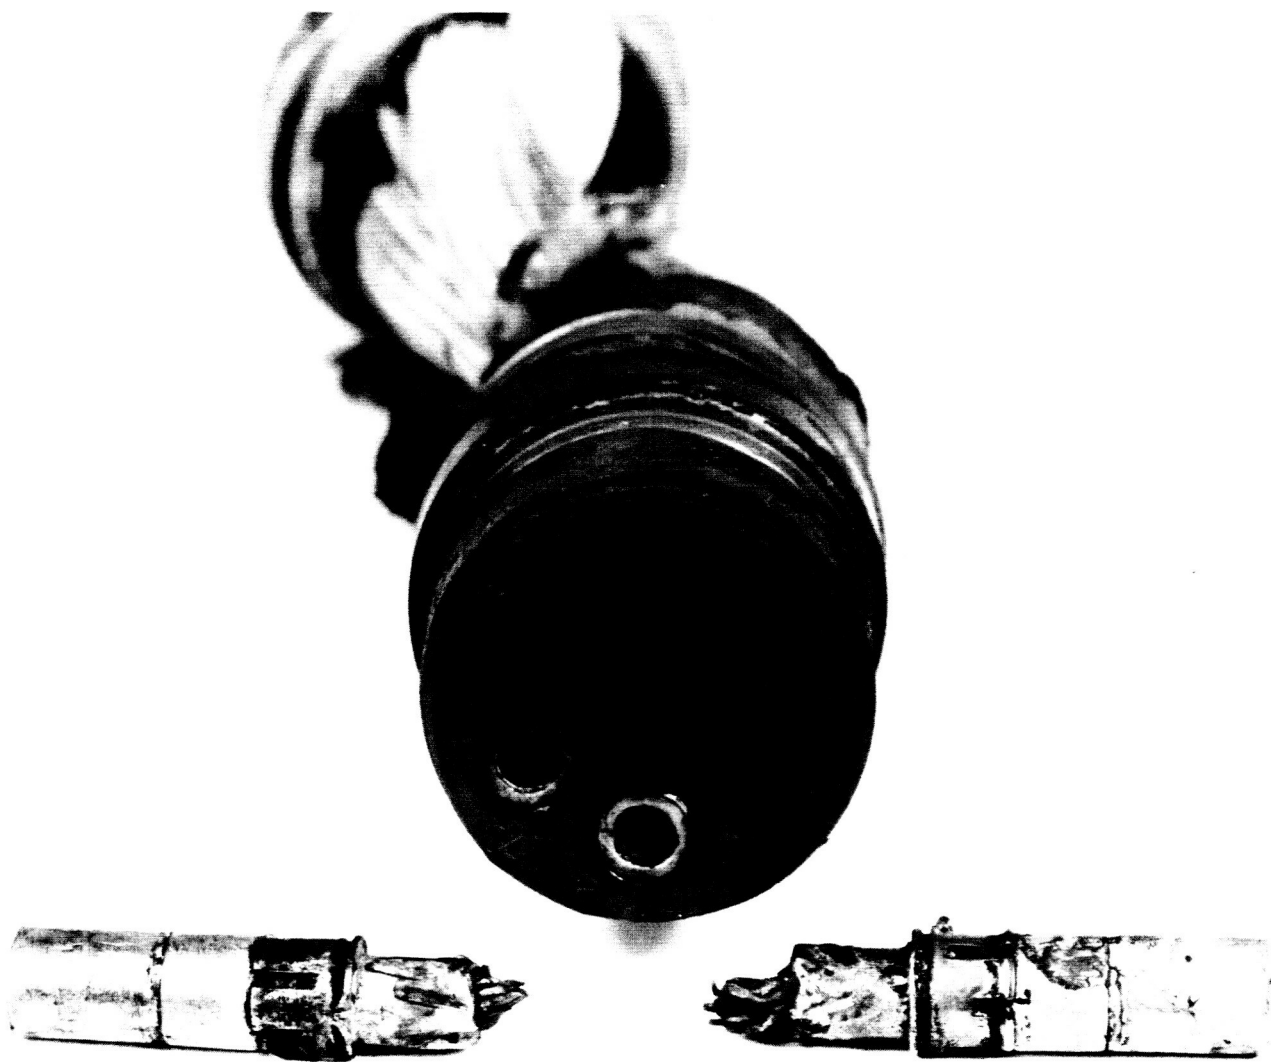
FIGURE 32

- a. The solder melted and partially ran out.
- b. The connector pins and copper wire strands were oxidized.

SUNFLOWER COMPONENT TEST RIG ELECTRICAL CONNECTOR AFTER 6741 HOURS OPERATION
